Re: Indoor Air Quality and Radon Assessment Report
Prince George's County Public Schools
Potomac Landing Elementary School
PO #887001

Windjammer Environmental LLC (Windjammer) was contracted to conduct an Indoor Air Quality (IAQ) assessment at Potomac Landing Elementary School located at 12500 Fort Washington Road, Fort Washington, MD 20744. This sampling event was conducted in preparation for student occupancy during the 2026-2027 school year. Industrial Hygienist, Nigel Robinson, performed the on-site evaluation on May 14, 2026; and deployed and collected radon sampling canisters from May 12th to May 14th, 2026.

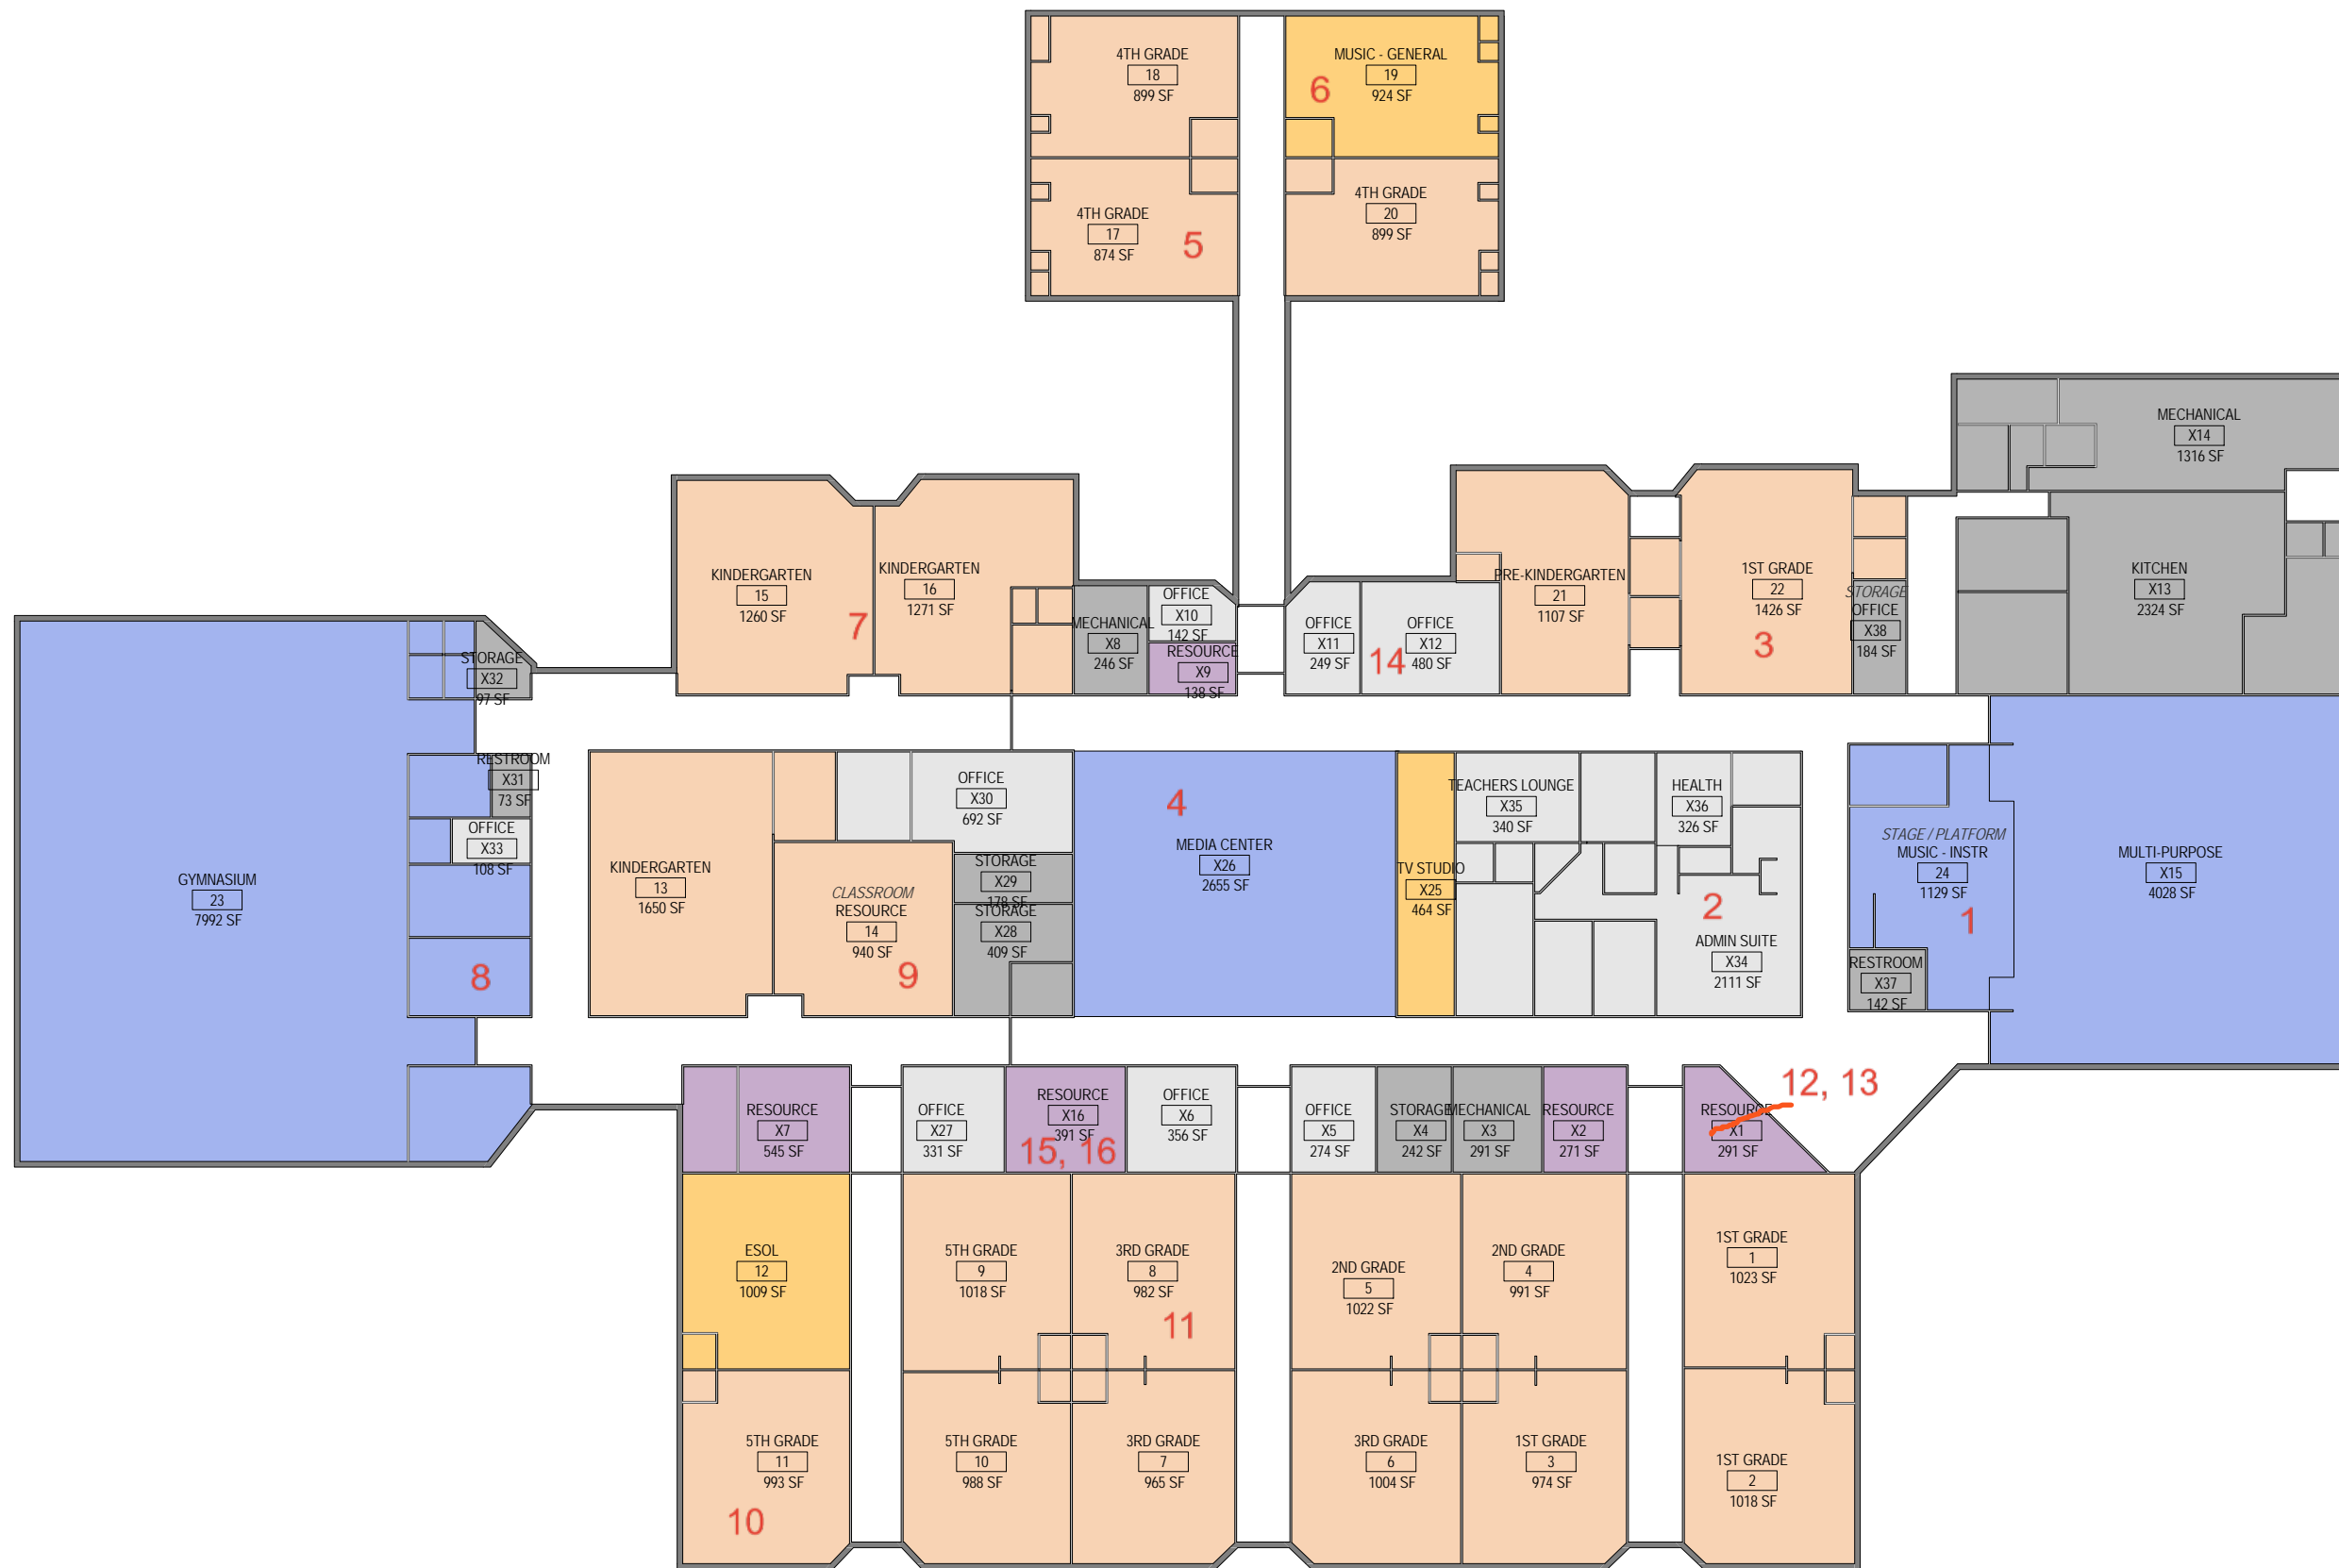
Attachment B: Radon Sampling Floor Plan

The laboratory results of the radon testing canisters collected at Potomac Landing Elementary School had concentrations below the EPA action level of 4 pCi/L. Radon sampling results are summarized in Table 2. The complete laboratory analysis report can be found in Attachment A. A floor plan with the location of each radon testing canister can be found in Attachment B.

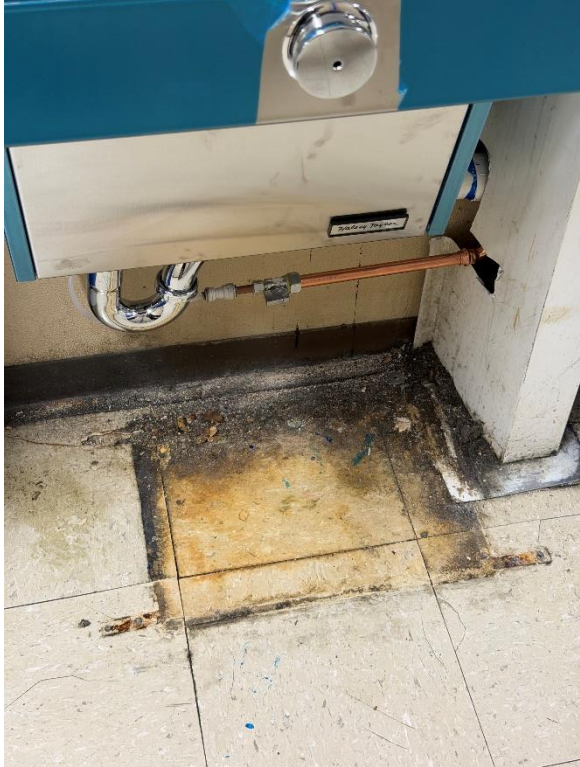
A visual assessment of the indoor classrooms was conducted in conjunction with the measurement of the aforementioned IAQ parameters. Evidence of water intrusion that was dry to touch was observed under the drinking water fountain between classrooms 19 and 20, and underneath the sink in classroom 8 (see Images 1 and 2). One (1) missing ceiling tile was observed by the east entrance to the gym (see Image 3). Light dust settlement was observed on furniture throughout the main school building. Housekeeping was observed acceptable and no evidence of active moisture damage, mold growth, or foul odors were noted. See Attachment C for referenced images.

Image 1
Hallway between Room 19 and 20
Dry water intrusion under water fountain.

- Inspect and clean all water sinks, drinking fountains, bathrooms, and any building components associated with active water pipes.
- Replace any missing and/or damaged ceiling tiles.
- Continue to maintain adequate housekeeping practices.
- Conduct an IAQ and radon assessment for the temporary classrooms, when construction and minor repairs are complete.

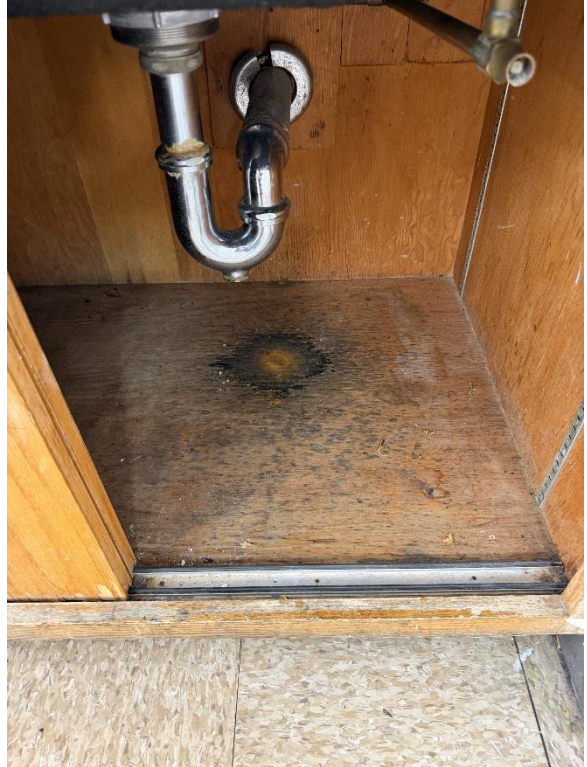
Image 2
Classroom 8
Dry water intrusion under water fountain.

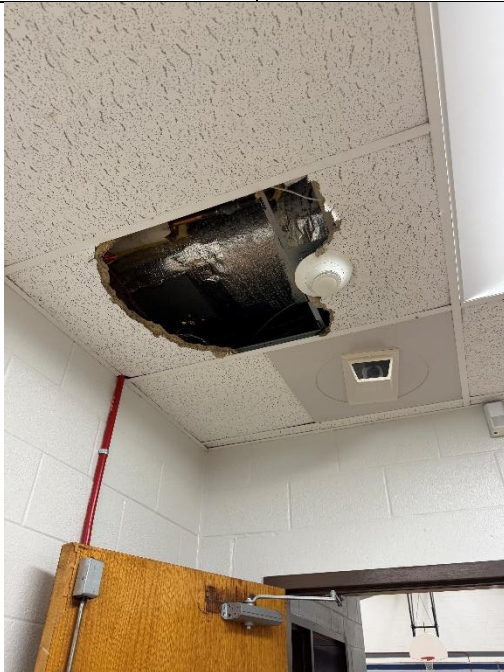
Image 3
Outside Gym Entrance
Missing ceiling tile.
